Sprinklers Control Arson Fires in Rack-Storage Warehouse Mt. Prospect, Illinois

Sprinklers Control Arson Fires in Rack-Storage Warehouse Mt. Prospect, Illinois (October 16, 1988)

This is Report 030 of the Major Fires Investigation Project conducted by TriData Corporation under contract EMW-88-C-2649 to the United States Fire Administration, Federal Emergency Management Agency.

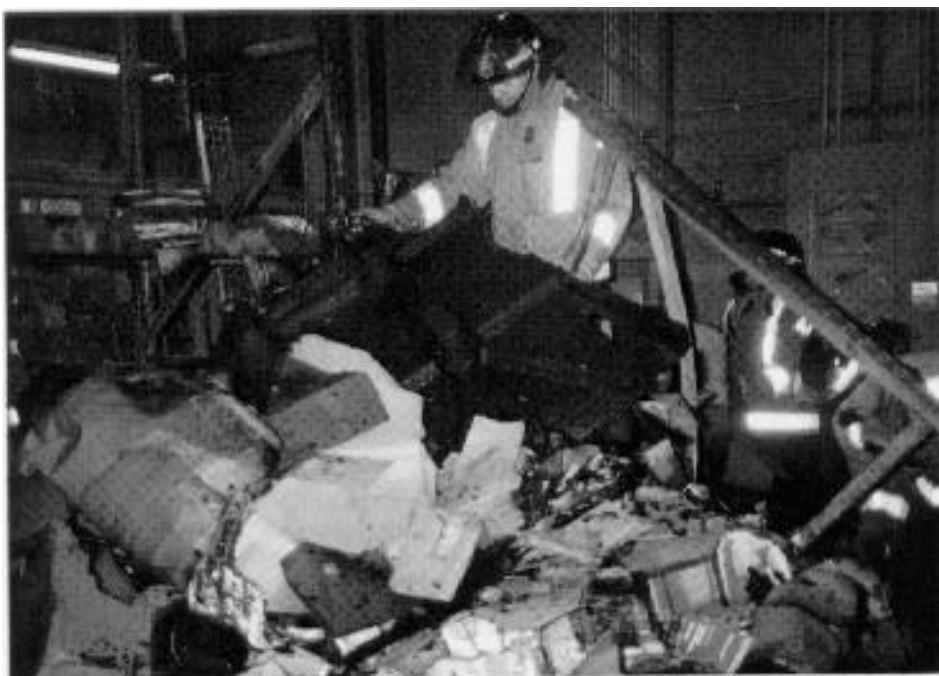
- *2. Looking due southwest from the second aisle. The main sprinkler riser is visible just above the firefighter's right hand.
3. Shows damage to goods stored.

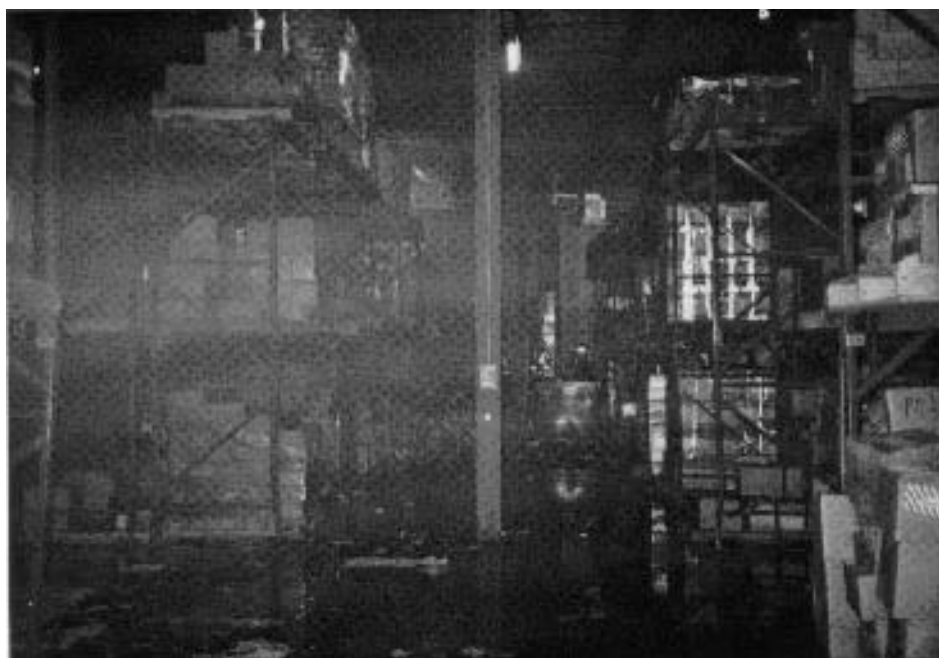
4. Shows break room with burglarized change machine.
- *5. Looking up aisle three, damage to rear of racks is evident at far end.
6. Main entrance to building.

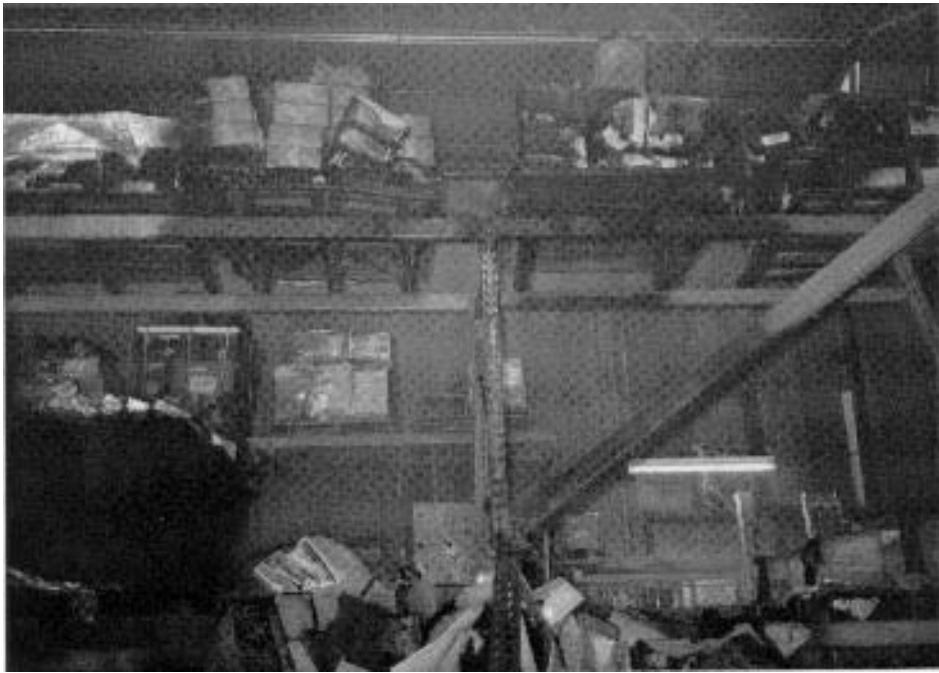
- *7. Typical damage to goods on upper level of racks.
8. Looking due south at door leading to warehouse section. Shows extent of water penetration due to fire.

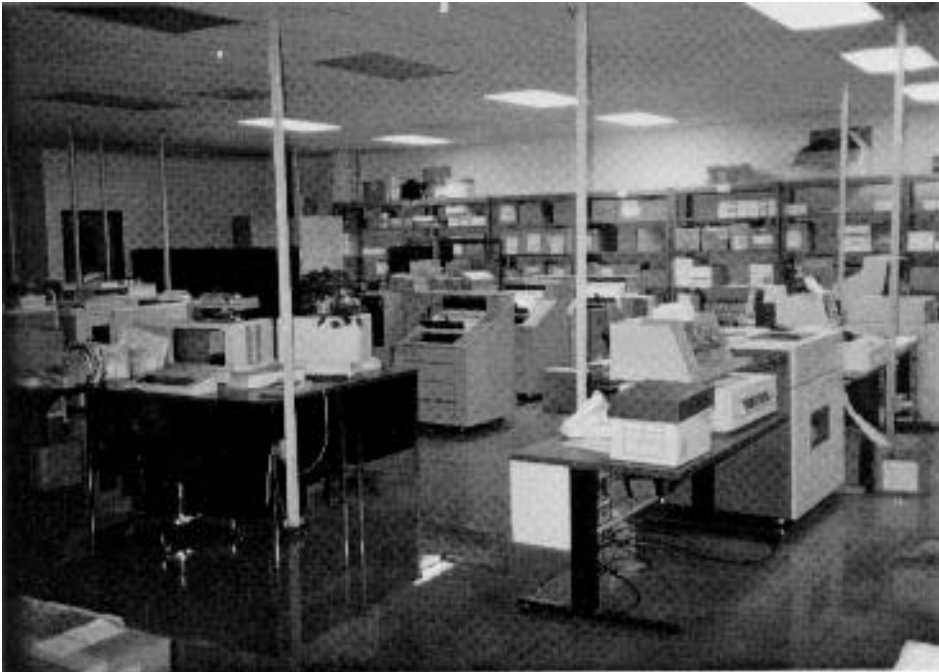
Successful operation of the sprinkler system, and the efficient manner in which the Fire Department attacked the fire, prevented it from spreading into the adjacent data processing rooms. These areas were found with several inches of water on the floor; however, no damage was suffered by any of the equipment.

- *9. Data processing room, showing water accumulation on floor.
10. Data processing room. Shows extent of water penetration. No damage to equipment.
- 11-14. From aisle two showing fire damage to first double rack and single rack at southwest end of warehouse.

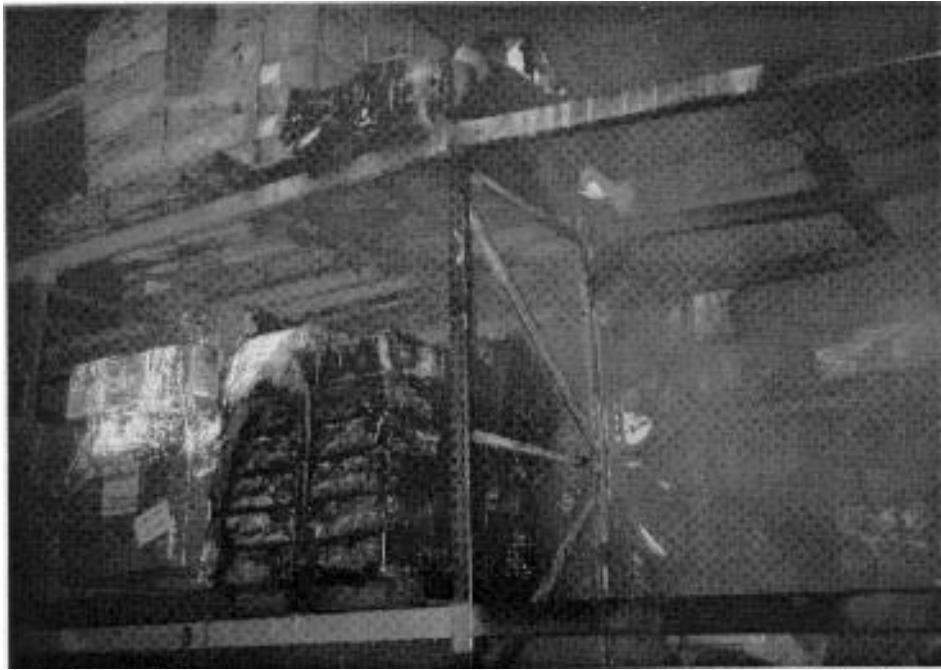
17. From aisle two showing fire damage to storage racks.
- *18. Typical fire damage to goods on rack in aisle two.
19. From aisle two, showing fire damage to storage racks.

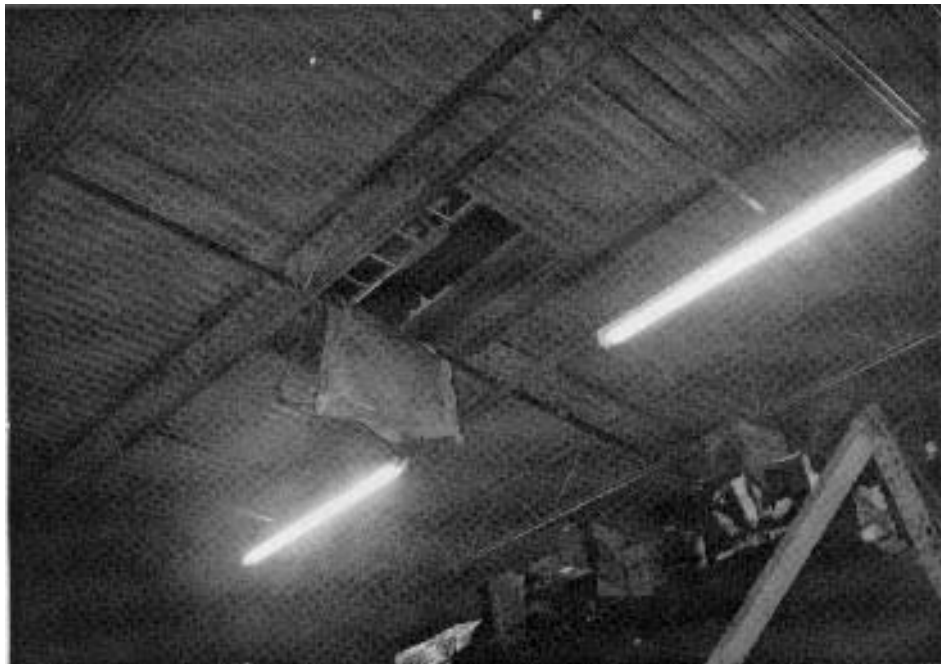
Although the building did not suffer any structural damage, a skylight located above the fire area failed prior to extinguishment. This failure is thought to have occurred soon after the time the first responding units arrived on the scene. This is based on the fact that no outward signs of

- *20. Failed skylight above aisle one. Note sprinkler piping.

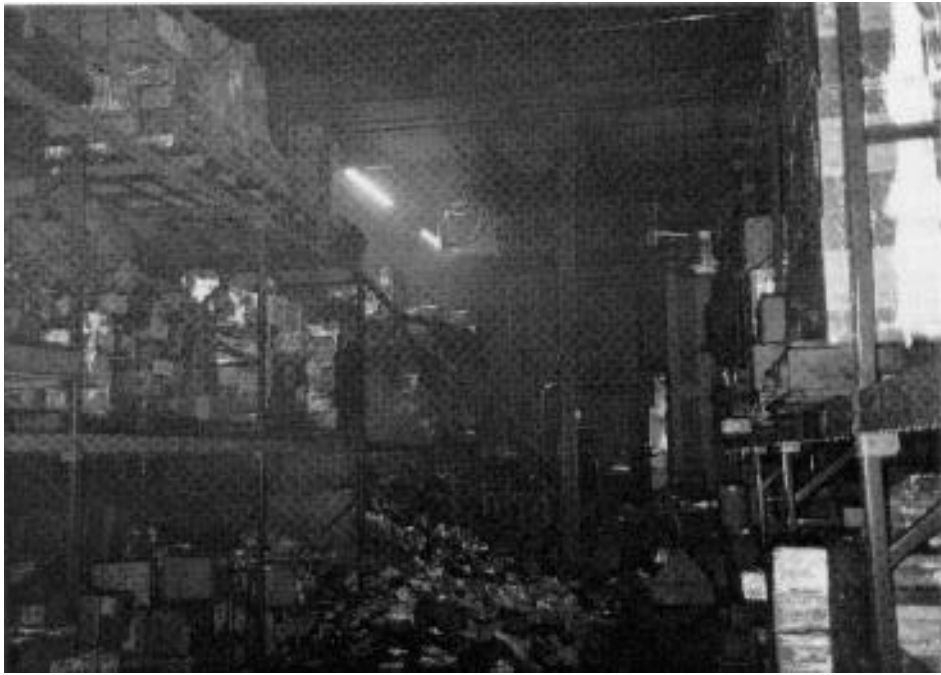
*28. Overall view of fire area showing damage to racks.
